Manhole Inspection Summary

Manhole # S69K__001MH

Location Address: **6709 Fait Ave.**

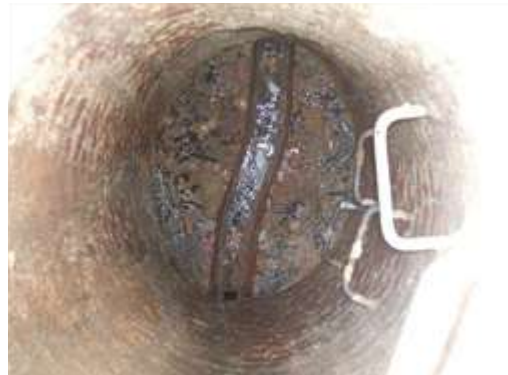
Top View

O12 top of picture

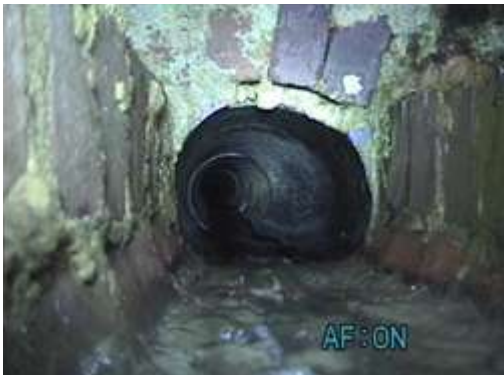
Defect 1

Cracks multiple 11:00-2:00 outgoing 12 O'Clock

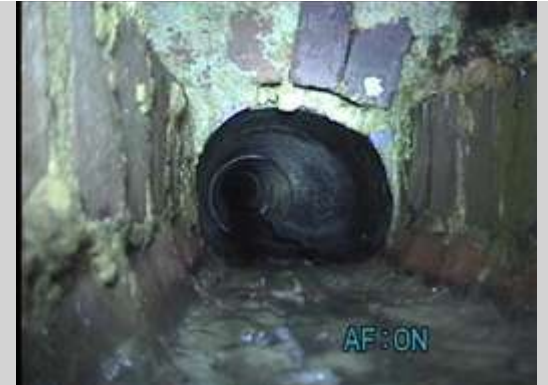
12 O'Clock Outflow

10 in. Circular Gravity Sewer
Pipe Out @ 12 O'Clock

Pipe Height: **9.6** (in.) Rod and Bar (Angled)
Pipe Material: **Clay** ☐ Pipe Lined
Invert Depth: **10.00** (ft.) Flow Characteristics: **Slow**
Deposits: ☐ None ☐ Mud ☐ Gravy ☒ **Debris** ☐ Grease
Silt Depth: **0.25** (in.) Deposits Extent: **Light**
Infiltration: **None** Pipe Seal Cond: **Sound**

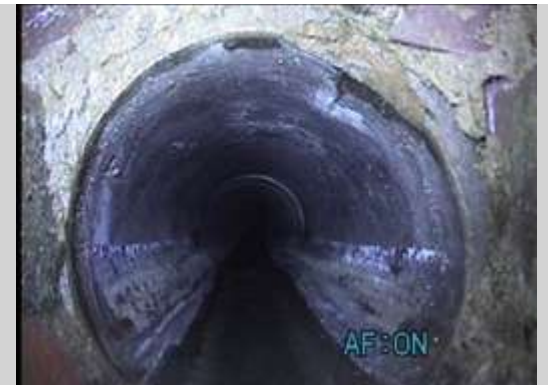
6 O'Clock Inflow

10 in. Circular Gravity Sewer
Pipe In @ 6 O'Clock

Pipe Height: **9.6** (in.) Rod and Bar (Angled)
Pipe Material: **Clay** ☐ Pipe Lined
Invert Depth: **9.92** (ft.) Flow Characteristics: **Slow**
Deposits: ☐ None ☐ Mud ☒ Gravy ☒ **Debris** ☐ Grease
Silt Depth: **0.25** (in.) Deposits Extent: **Light**
Infiltration: **None** Pipe Seal Cond: **Sound**
